BMW M4 Coupe 2015

Technical Service Bulletin: S1 B51 36 15

SI B51 36 15
Body Equipment

Service Action: Repair the PVC seam on the left rear light

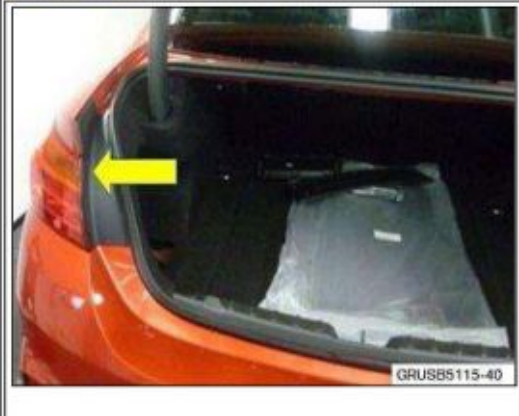
| | <ol style="list-style-type: none"> 1. Remove the left tail light. Refer to Repair Instruction REP 63 21 260. |

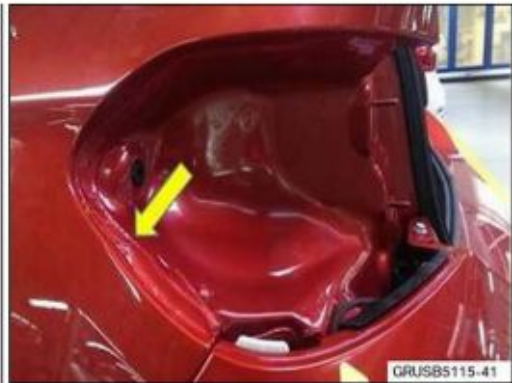
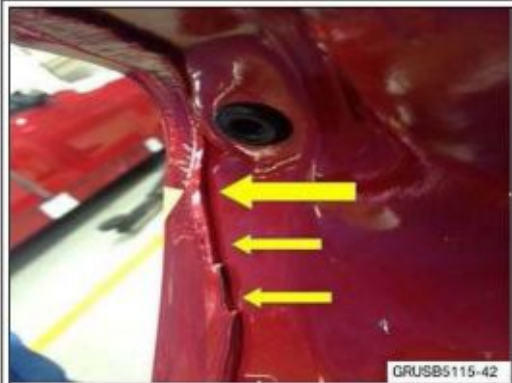
The left rear light PVC seam may not have been applied properly and may be leaking.

The PVC seam was not applied correctly and can cause water leaks.

| | <ol style="list-style-type: none"> 2. Seal the area of the PVC seam that shows waviness or is incomplete. |

3. Do not remove the existing PVC seal and only apply PVC sealer to the wavy area.

4. After the seam sealer has dried, reassemble the vehicle, then check for water leaks into the interior and the control unit recess near the left side.
