#15183: Service Update for Inventory and Customer Vehicles - Driver's Side Front Roof Ditch Molding Water Leak - (Mar 18, 2015)

Subject: 15183 – Service Update for Inventory and Customer Vehicles – Driver's Side Front Roof Ditch Molding Water Leak – Expires with Base Warranty

Models: 2015 Cadillac Escalade
2015 Chevrolet Tahoe
2015 GMC Yukon

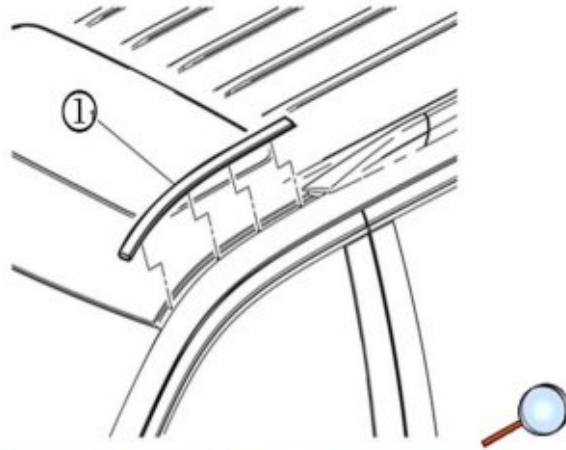
Note: Due to the likelihood of the retaining clips being damaged during molding removal, replacement of the finish molding is recommended.

1. Remove the left roof panel joint finish molding (1). Refer to *Roof Panel Joint Finish Molding Replacement* in SI.

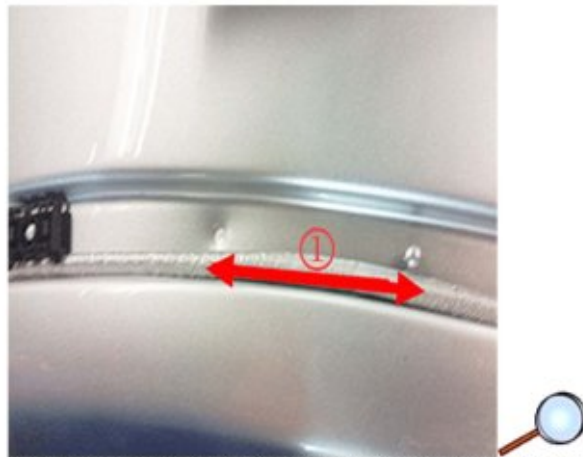
2. In the area between the forward roof weld and the second roof stud (1), inspect for voids/gaps in the seam sealer **along the outboard edge** of the roof ditch.

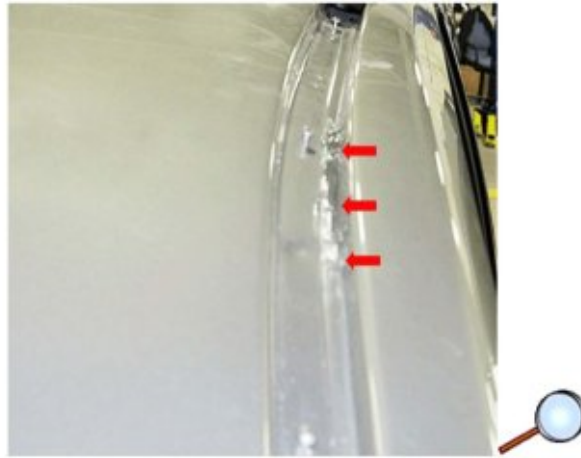
Note: During sealer application, avoid excess sealer build up within the ditch, while assuring there are no voids in the full bead of sealer.

3. Overlapping at least 25 mm (1.0 in) each side, apply a maximum height 0.4 mm (0.157 in) bead of Kent Automotive High-Tech™ Clear Seam Sealer, the length of the area.
